**Flood Control Project Maintenance
Levee Inspections**

Fall 2015 Levee Maintenance Deficiency Summary Report

Sacramento River Basin

Reclamation District No. 0537 Lovdal

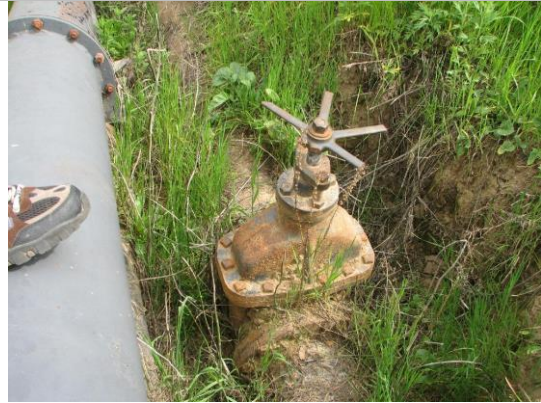
Photo 1 of 3 : UCIP_FA_2015_0237.jpg

Inspector Comments: FS_ID:46806
 DS_ID:180
 EP_NO: 4656
 FS_HLM: 2.974
 Repair Type: Non-Urgent
 Crossing Status: Found
 UCIP Comments: Broken gate valve handle on waste pipe.
 FIELD_STRUCT_DESC: 12-inch irrigation pipe through the levee, 7.0 feet below the crown. Slant pump column on the bank. Timber walkway mounted on pile structure across the berm to pump. Siphon breaker on CM pipe riser on the landward slope. Concrete pipe riser on the landward side. A waste pipe down bank. Gate valve on waste line.
 (Permit No. 4656)
 FS Date: 03/18/2013

WS- main pipe and waste pipe with gate valve

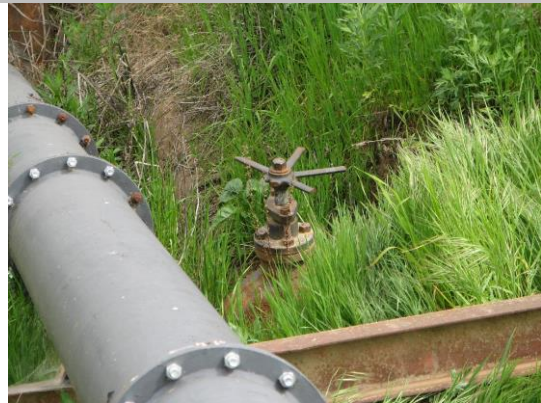
Photo 2 of 3 : UCIP_FA_2015_0238.jpg

WS- main pipe and waste pipe with gate valve

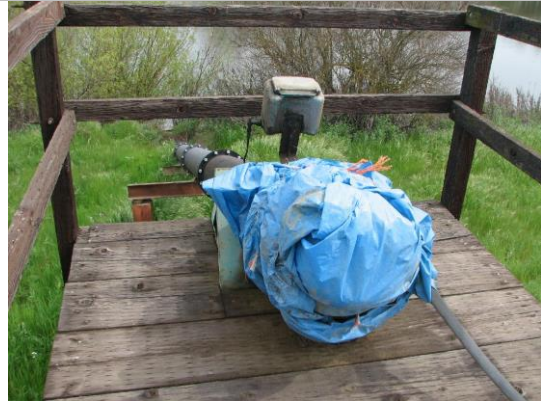
Photo 3 of 3 : UCIP_FA_2015_0239.jpg

WS- slanted pipe and pump on timber structure.

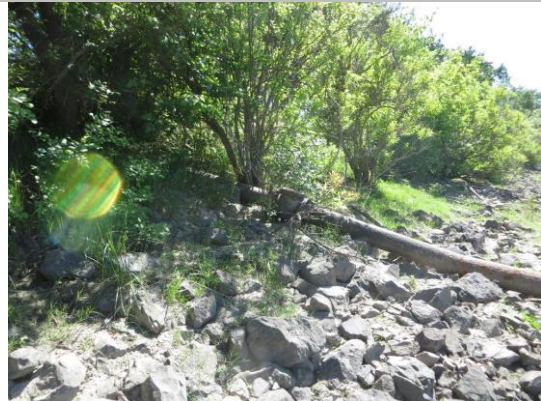
Photo 1 of 3 : UCIP_FA_2015_5968.jpg

LM Start		Rating **	M	Issue No.	956
LM End		Issue Type +	En	Location *	LS
Category	Supplemental			GPS Latitude/Longitude	
				Start	End
Item	DWR UCIP Field Study			38.643528 °	38.643528 °
				-121.583193 °	-121.583193 °
DWR ID					
Action/Comments					
Inspector Comments: FS_ID:46803					
DS_ID:168					
EP_NO: N/A					
FS_HLM: 0.06					
Repair Type: Non-Urgent					
Crossing Status: Found					
UCIP Comments: Crossing appears abandoned; if so, must be done so properly.					
FIELD_STRUCT_DESC: 10-inch steel irrigation pipe, 3.8 FBC. Pump gone. Concrete pump pad on WS bank not found. 36-inch concrete standpipe off LS toe. 2-inch electric conduit not found (1-inch electric line found for 10-inch pipe located 50 ft upstream). Plate bolted on WW end of pipe. FBIIIP 2004 Levee Logs.					
FS Date: 04/29/2015

Pipe visible along WS slope.

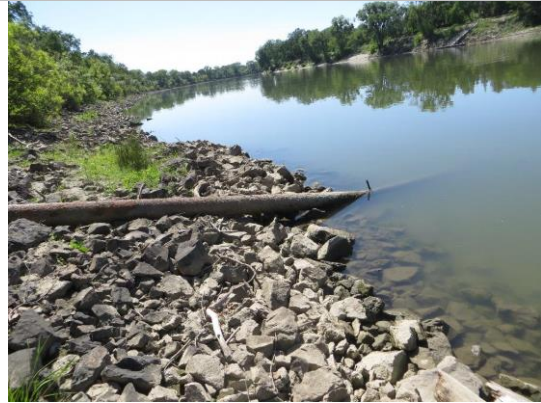
Photo 2 of 3 : UCIP_FA_2015_5969.jpg

View of pipe into water.

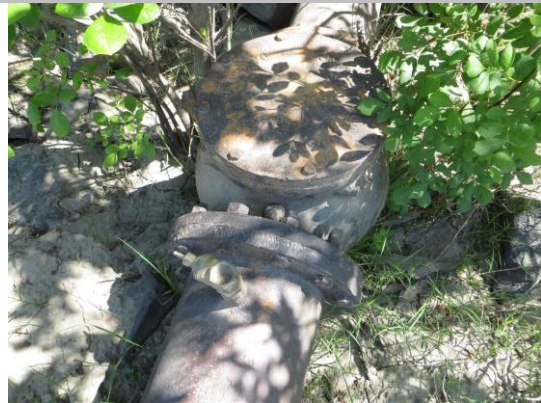
Photo 3 of 3 : UCIP_FA_2015_5970.jpg

Closeup of plates bolted to pipe on WS slope.

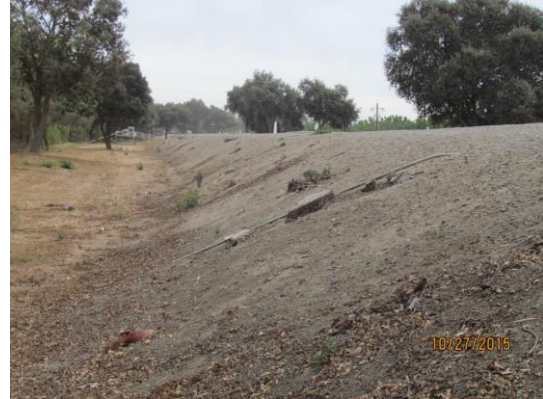
Photo 1 of 1 : FA_2015_RD0537_173_22_20151102_00060.jpg

View of the tree stumps on the waterward side of the levee looking downstream. Fall 2015.

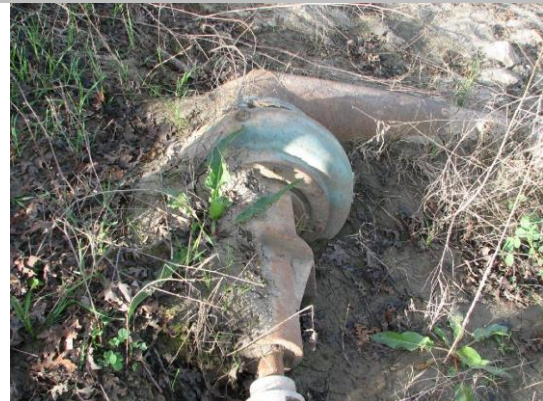
Photo 1 of 3 : UCIP_FA_2015_0342.jpg

LM Start	0.05	Rating **	U	Issue No.	957
LM End	0.05	Issue Type +	En	Location *	WS
Category	Supplemental			GPS Latitude/Longitude	
				Start	End
Item	DWR UCIP Field Study			38.643400 °	38.643400 °
				-121.583380 °	-121.583380 °
DWR ID					
Action/Comments					
Inspector Comments: FS_ID:46165 DS_ID:169 EP_NO: N/A FS_HLM: 0.051 Repair Type: Urgent Crossing Status: Found UCIP Comments: Crossing appears abandoned; if so, must be done so properly. Cracking on pavement along pipe alignment. Holes visible on pipe along WS slope. FIELD_STRUCT_DESC: 10-inch steel irrigation pipe thru levee, 18 ft below crown (not 6.7 ft per permit drawing). Pump on WS found. Concrete collar on WS per permit drawing not found. PVC standpipe and valve enclosed by concrete standpipe off LS toe. 1-inch electric conduit thru levee, 3.8 ft below crown (not 2-inch as per LL). Permit No. 558, 1932. FPIIB 2004 Levee Log (at LM 0.04). FS Date: 03/18/2013

WS- an abandoned pump.

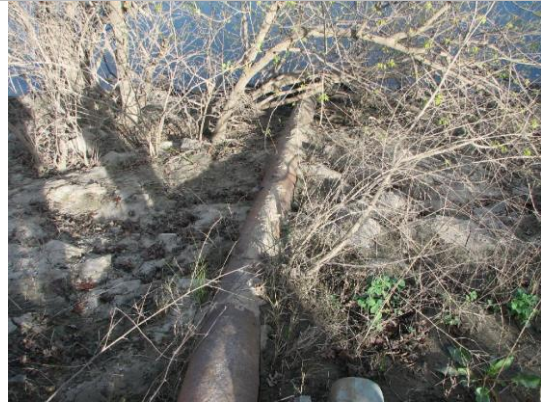
Photo 2 of 3 : UCIP_FA_2015_0343.jpg

WS- abandoned steel pipe.

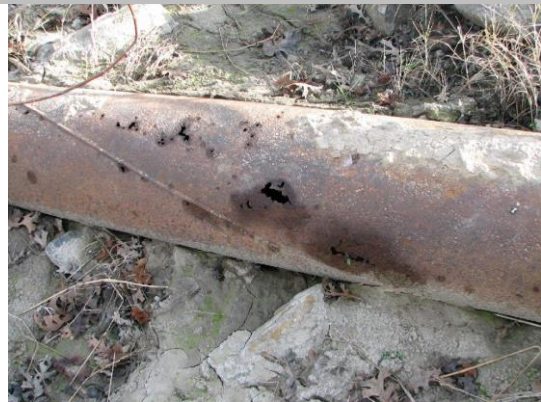
Photo 3 of 3 : UCIP_FA_2015_0344.jpg

WS- visible holes on the pipe.

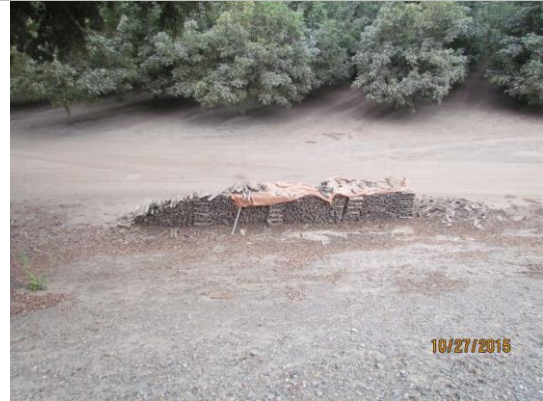
Photo 1 of 2 : FA_2015_RD0537_173_47_20151102_00035.jpg

View of the firewood pile at the toe of the levee on the landward side. Fall 2015.

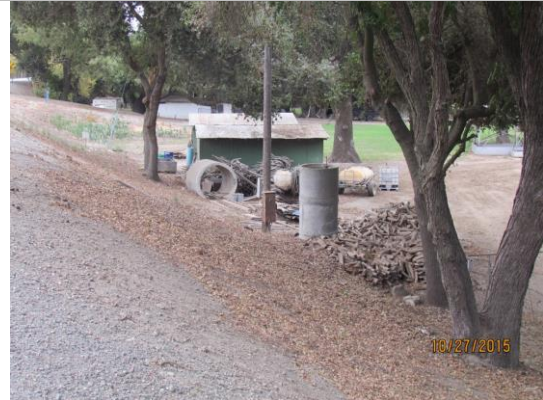
Photo 2 of 2 : FA_2015_RD0537_173_47_20151102_00036.jpg

Perspective view of more firewood at the toe of the levee on the landward side looking downstream. Fall 2015.

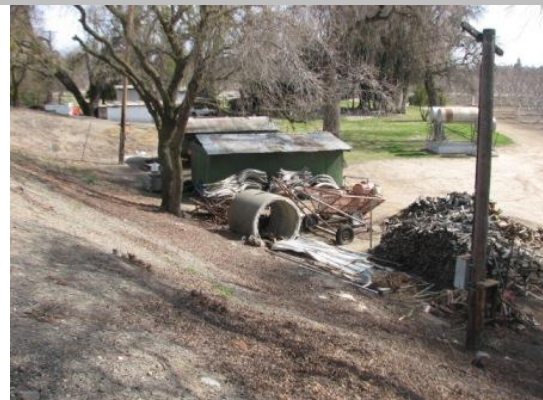
Photo 1 of 3 : FA_2015_RD0537_173_6_20150914_00006.jpg

LM Start	0.39	Rating **	M	Issue No.	6
LM End	0.39	Issue Type +	En	Location *	LS
Category	Earthen Levee			GPS Latitude/Longitude	
				Start	End
Item	Encroachments			38.646547 °	38.646547 °
				-121.578534 °	-121.578534 °
DWR ID	DWR_RD0537_01_s _ 2013_6				
Action/Comments					
Equipment					
Inspector Comments: Also building is in the easement.

Irrigation pipe and equipment along the levee toe. Spring 2013

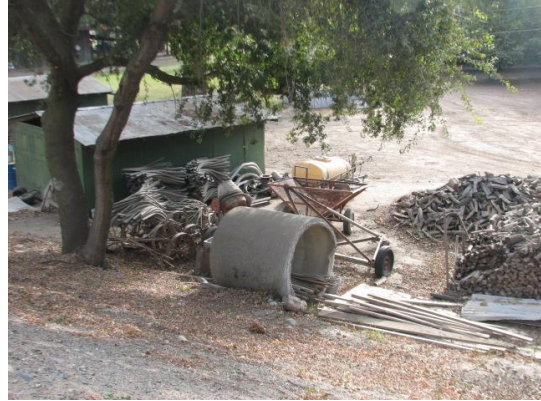
Photo 2 of 3 : FA_2015_RD0537_173_6_20150914_00007.jpg

The equipment is still within the easement. Fall 2013

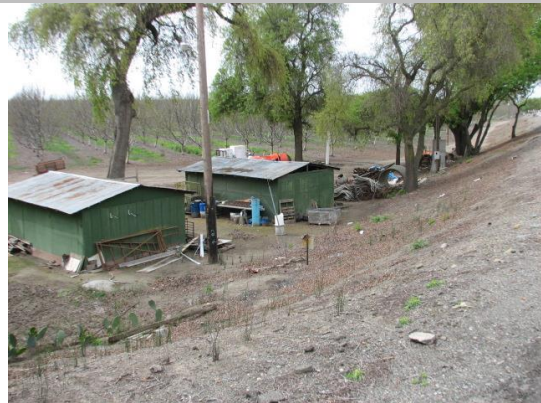
Photo 3 of 3 : FA_2015_RD0537_173_6_20150914_00008.jpg

The equipment and pipe at the levee toe. Spring 2014

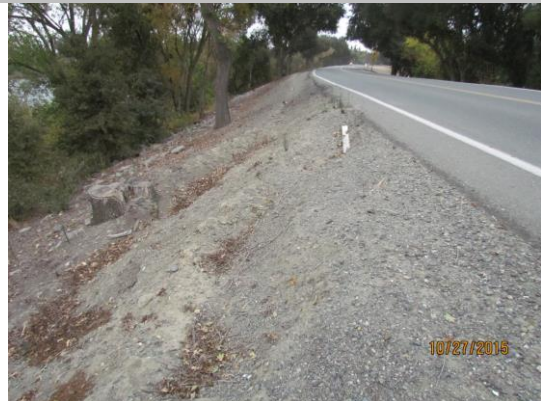
Photo 1 of 1 : FA_2015_RD0537_173_21_20151102_00059.jpg

LM Start	0.40	Rating **	M	Issue No.	21
LM End	0.40	Issue Type +	Ma	Location *	WS
Category	Earthen Levee			GPS Latitude/Longitude	
				Start	End
Item	Slope Stability			38.646696 °	38.646696 °
				-121.578418 °	-121.578418 °
DWR ID	DWR_RD0537_01_f_2015_21				
Action/Comments					
Repair the levee slope damaged by vehicle traffic and prevent access where possible.

View of the slope stability on the waterward side of the levee looking downstream. Fall 2015.

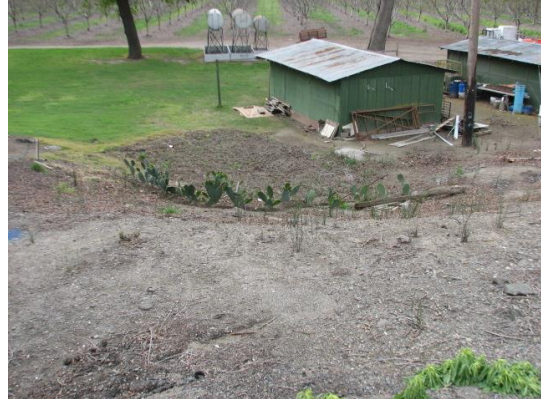
Photo 1 of 1 : FA_2015_RD0537_173_18_20150914_00015.jpg

The cactus is still growing along the levee slope. Spring 2014

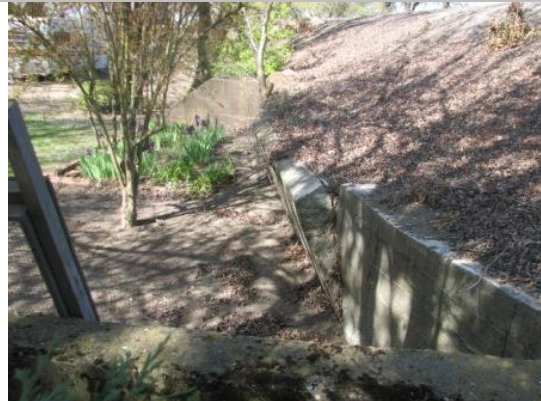
Photo 1 of 3 : FA_2015_RD0537_173_50_20150914_00020.jpg

A closer view of the retaining wall, spring 2012.

LM Start	0.44	Rating **	M	Issue No.	50
LM End	0.44	Issue Type +	Ma	Location *	LS
Category	Earthen Levee			GPS Latitude/Longitude	
				Start	End
Item	Slope Stability			38.647005 °	38.647005 °
				-121.577813 °	-121.577813 °
DWR ID	DWR_RD0537_01_s_2012_50				
Action/Comments					
Repair slope instability.

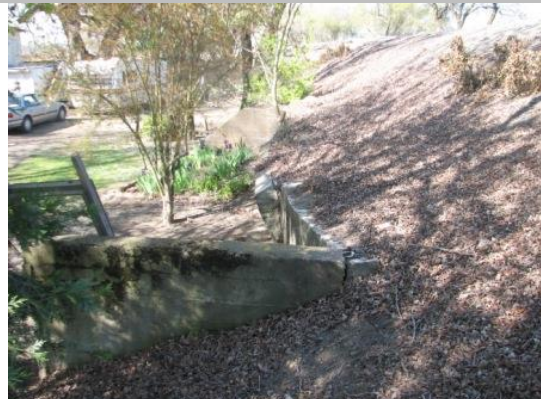
Photo 2 of 3 : FA_2015_RD0537_173_50_20150914_00021.jpg

Concrete retaining wall broken and leaning. Slope instability, photo taken spring 2012.

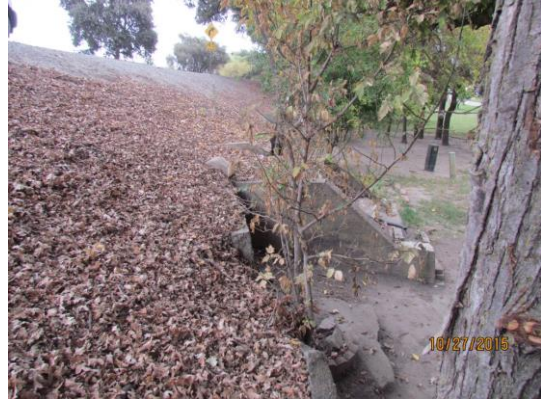
Photo 3 of 3 : FA_2015_RD0537_173_50_20151102_00037.jpg

View of the retaining wall at the levee toe on the landward side of the levee looking downstream. The wall is partially broken. Fall 2015.

LM Start	0.44	Rating **	M	Issue No.	50 (cont)	
LM End	0.44	Issue Type +	Ma	Location *	LS	
Category	Earthen Levee			GPS Latitude/Longitude		
				Start		End
Item	Slope Stability			38.647005 °		38.647005
				-121.577813 °		-121.577813
DWR ID	DWR_RD0537_01_s _ 2012_50					
Action/Comments						
Repair slope instability.

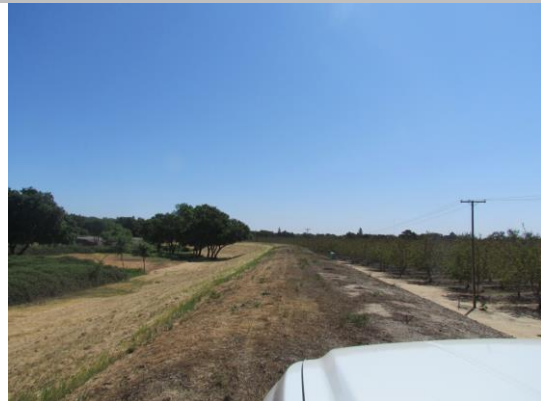
Photo 1 of 1 : FA_2015_RD0537_173_471_20150914_00025.jpg

View of the crown of the levee looking downstream. Spring 2015.

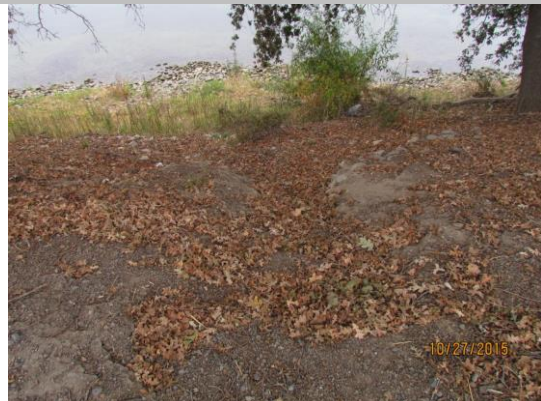
Photo 1 of 2 : FA_2015_RD0537_173_954_20151102_00039.jpg

Looking down on the erosion site towards the river. Fall 2015.

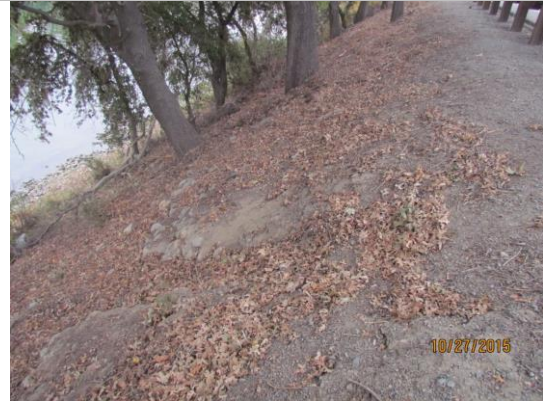
Photo 2 of 2 : FA_2015_RD0537_173_954_20151102_00040.jpg

Perspective view of the erosion site at Monument Bend on the waterward side of the levee looking downstream. Fall 2015.

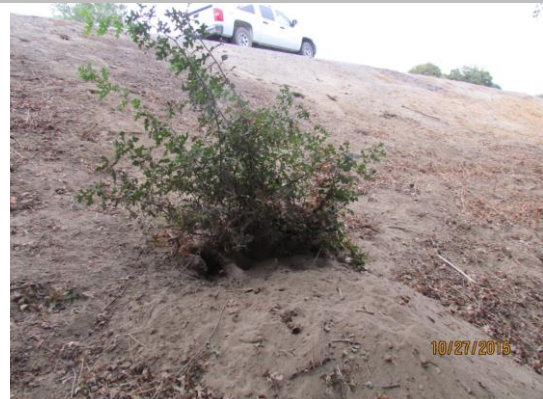
Photo 1 of 2 : FA_2015_RD0537_173_40_20151102_00043.jpg

View of the rodent holes on the landward side of the levee looking down. Fall 2015.

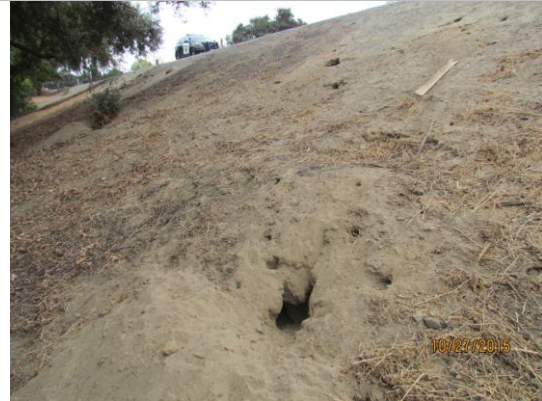
Photo 2 of 2 : FA_2015_RD0537_173_40_20151102_00041.jpg

View of the rodent holes on the landward side of the levee looking upstream. There are more than 2 cubic feet of material from the hole Fall 2015.

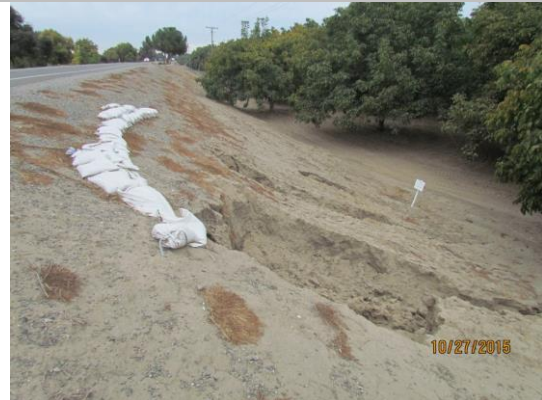
Photo 1 of 2 : FA_2015_RD0537_173_472_20151102_00044.jpg

Perspective view of the erosion on the landward side of the levee looking downstream. Fall 2015.

LM Start	1.99	Rating **	U	Issue No.	472
LM End	1.99	Issue Type +	Ma	Location *	LS
Category	Earthen Levee			GPS Latitude/Longitude	
				Start	End
Item	Erosion / Bank Caving			38.631957 °	38.631957 °
				-121.564435 °	-121.564435 °
DWR ID	DWR_RD0537_01_s _ 2015_472				
Action/Comments					
Schedule repair of erosion site prior to the next inspection.

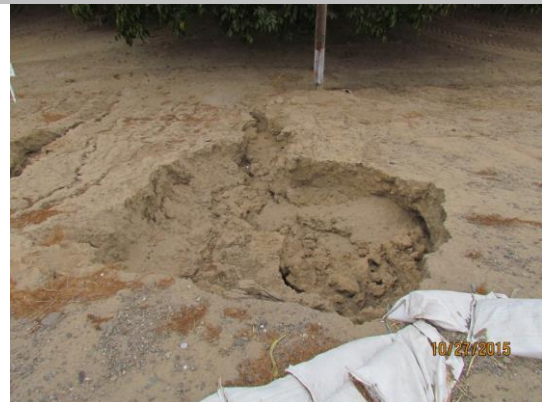
Photo 2 of 2 : FA_2015_RD0537_173_472_20151102_00045.jpg

A close up view of the erosion site. Fall 2015.

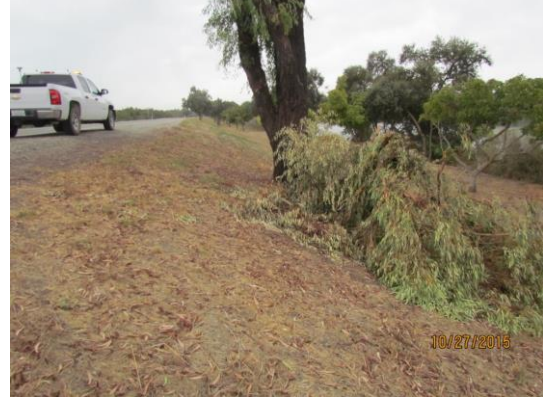
Photo 1 of 1 : FA_2015_RD0537_173_20_20151102_00058.jpg

View of the fallen tree limb on the waterward side of the levee looking upstream. Fall 2015.

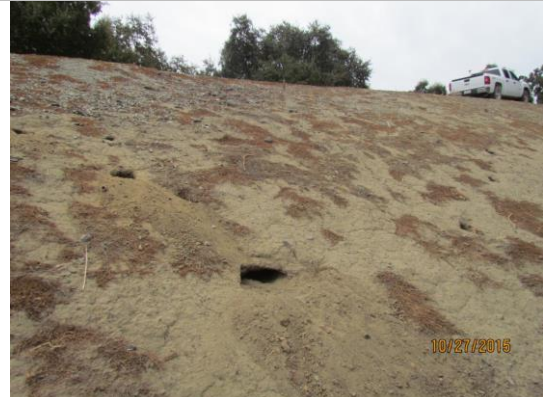
Photo 1 of 1 : FA_2015_RD0537_173_7_20151102_00046.jpg

View of the rodent hole on the landward side of the levee. Fall 2015.

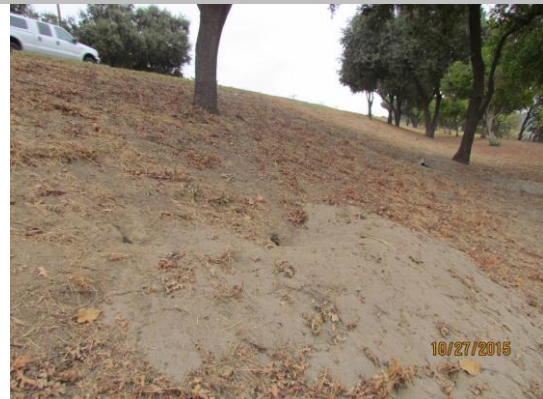
Photo 1 of 1 : FA_2015_RD0537_173_17_20151102_00057.jpg

View of the rodent hole on the waterward side of the levee looking upstream. There are more than 2 cubic feet of material next to the hole. Fall 2015.

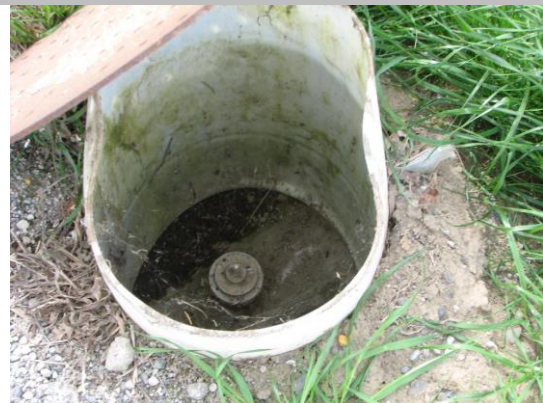
Photo 1 of 3 : UCIP_FA_2015_0205.jpg

LM Start	2.72	Rating **	M	Issue No.	958
LM End	2.72	Issue Type +	En	Location *	LS
Category	Supplemental			GPS Latitude/Longitude	
				Start	End
Item	DWR UCIP Field Study			38.621437 °	38.621437 °
				-121.563373 °	-121.563373 °
DWR ID					
Action/Comments					
Inspector Comments: FS_ID:46035 DS_ID:178 EP_NO: N/A FS_HLM: 2.756 Repair Type: Non-Urgent Crossing Status: Found UCIP Comments: Wasted pipe and valve not visible due to vegetation. FIELD_STRUCT_DESC: 12-inch pipe through the levee, 4.5 feet below the crown. Slant pump column on the waterward bank. Timber walkway (not found) mounted on pile structure across the berm. Siphon breaker in CM pipe riser on the landward slope. Concrete standpipe on the landward side. 6-inch wasted pipe down bank, gate valve on waste line. A 2" electrical conduit through the levee. FS Date: 03/18/2013

LS- siphon breaker in pvc pipe riser.

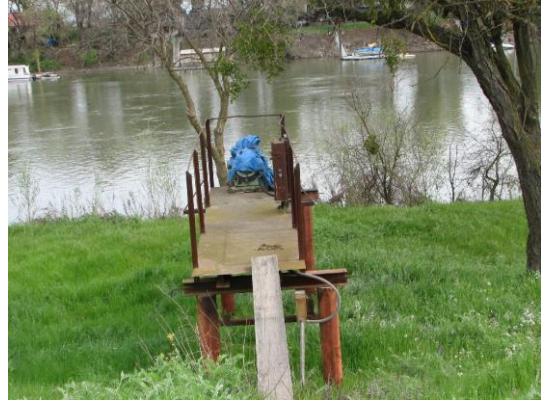
Photo 2 of 3 : UCIP_FA_2015_0206.jpg

Inspector Comments: FS_ID:46035
 DS_ID:178
 EP_NO: N/A
 FS_HLM: 2.756
 Repair Type: Non-Urgent
 Crossing Status: Found
 UCIP Comments: Wasted pipe and valve not visible due to vegetation.
 FIELD_STRUCT_DESC: 12-inch pipe through the levee, 4.5 feet below the crown. Slant pump column on the waterward bank. Timber walkway (not found) mounted on pile structure across the berm. Siphon breaker in CM pipe riser on the landward slope. Concrete standpipe on the landward side. 6-inch wasted pipe down bank, gate valve on waste line. A 2" electrical conduit through the levee.
 FS Date: 03/18/2013

WS- closer view of pump, pipe and steel structure.

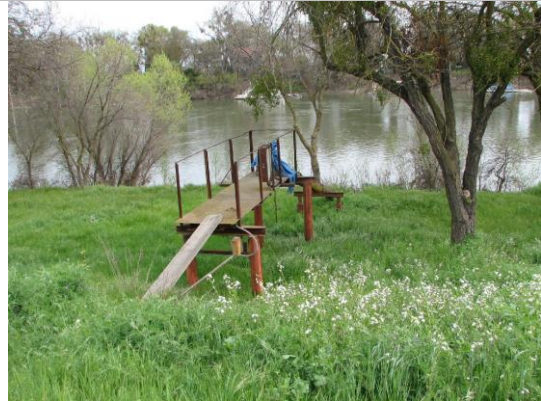
Photo 3 of 3 : UCIP_FA_2015_0207.jpg

WS- overview of pump, pipe and steel structure structure.

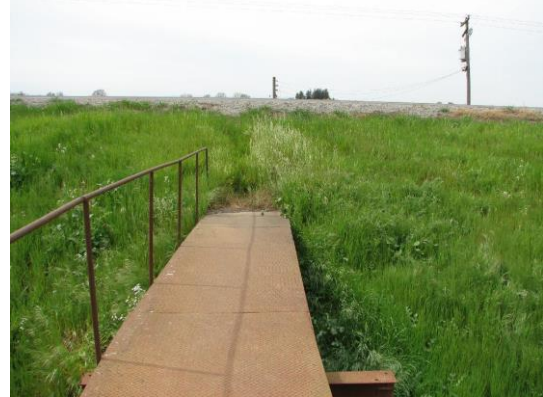
Photo 1 of 3 : UCIP_FA_2015_0208.jpg

WS- steel walkway on pile structure.

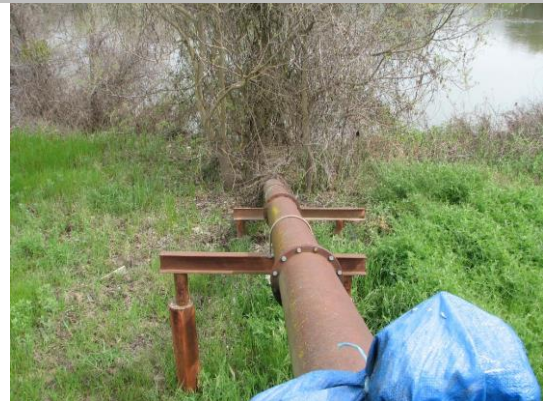
Photo 2 of 3 : UCIP_FA_2015_0209.jpg

WS- slanted pump and pipe on steel structure.

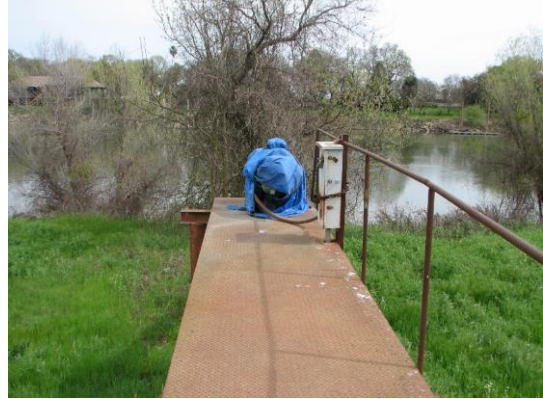
Photo 3 of 3 : UCIP_FA_2015_0210.jpg

WS- overview of slanted pump on steel structure.

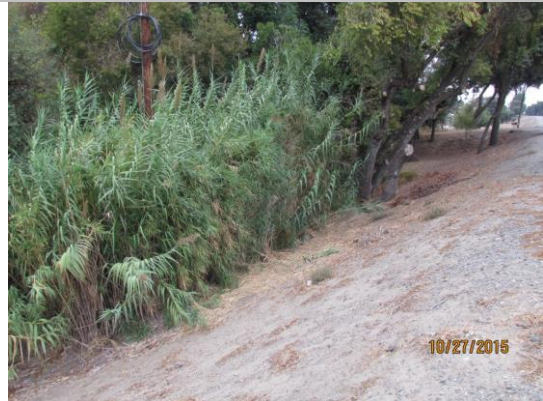
Photo 1 of 1 : FA_2015_RD0537_173_3_20151102_00047.jpg

View of the arundo at the levee toe on the landward side of the levee looking upstream. Fall 2015.

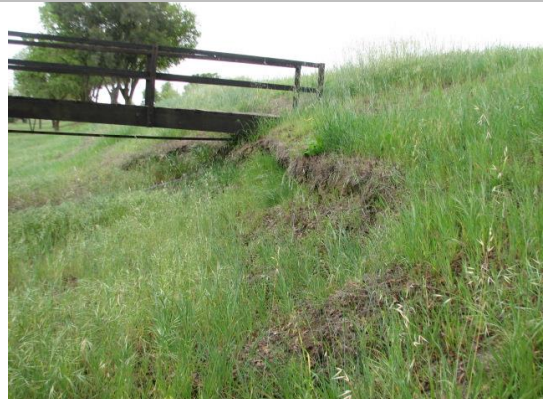
Photo 1 of 3 : FA_2015_RD0537_173_264_20150914_00023.jpg

LM Start	3.06	Rating **	M	Issue No.	264
LM End	3.06	Issue Type +	Ma	Location *	WS
Category	Earthen Levee			GPS Latitude/Longitude	
				Start	End
Item	Erosion / Bank Caving			38.616504 °	38.616504 °
				-121.563270 °	-121.563270 °
DWR ID	DWR_RD0537_01_s_2014_264				
Action/Comments					
Schedule repair of erosion site prior to the next inspection. Inspector Comments: The previous erosions from Spring 2014 are corrected, however, there is erosion under the gangway.

Erosion cut 20 feet from the other one. Erosion 2-3 feet deep. Spring 2014

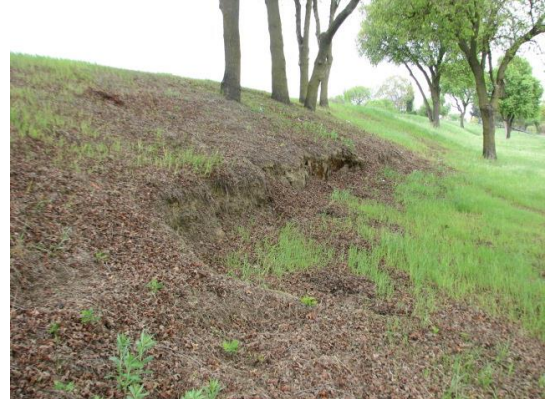
Photo 2 of 3 : FA_2015_RD0537_173_264_20150914_00024.jpg

Erosion cut in levee slope 2-3 feet deep. Spring 2014

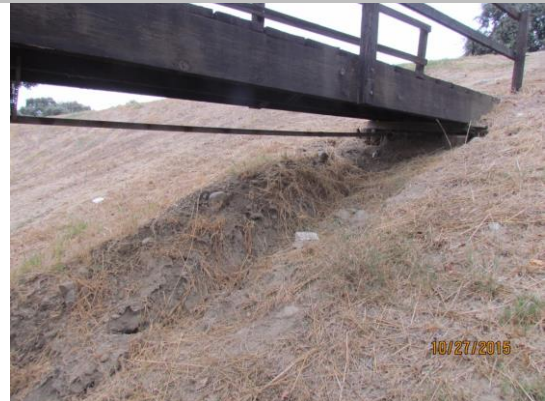
Photo 3 of 3 : FA_2015_RD0537_173_264_20151102_00056.jpg

There is erosion under the gangway on the waterward side of the levee looking downstream. Fall 2015.

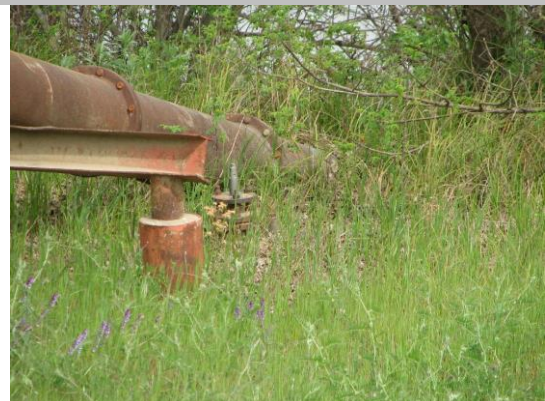
Photo 1 of 3 : UCIP_FA_2015_0358.jpg

WS- slanted pipe and waste pipe gate valve

Inspector Comments: FS_ID:46041
 DS_ID:181
 EP_NO: N/A
 FS_HLM: 3.109
 Repair Type: Non-Urgent
 Crossing Status: Found
 UCIP Comments: Obstructed siphon breaker.
 FIELD_STRUCT_DESC: 12-inch steel irrigation pipe through the levee, 7.0 feet below the crown. Slant pump column on the bank. Timber walkway mounted on pile structure across the berm to pump. Siphon breaker in CM pipe riser on the landward slope. Concrete standpipe on the landward side. 6-inch waste pipe down bank, gate valve on waste line.
 FS Date: 03/18/2013

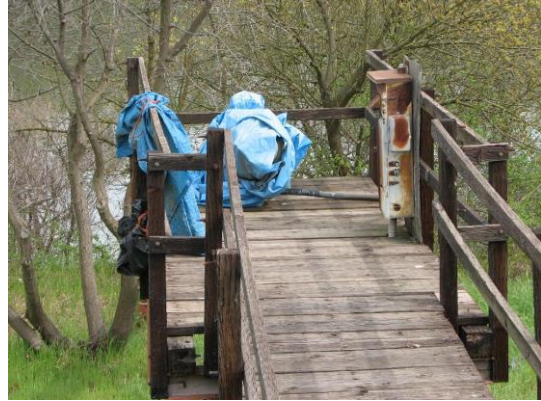
Photo 2 of 3 : UCIP_FA_2015_0359.jpg

WS- covered slanted pump on timber platform.

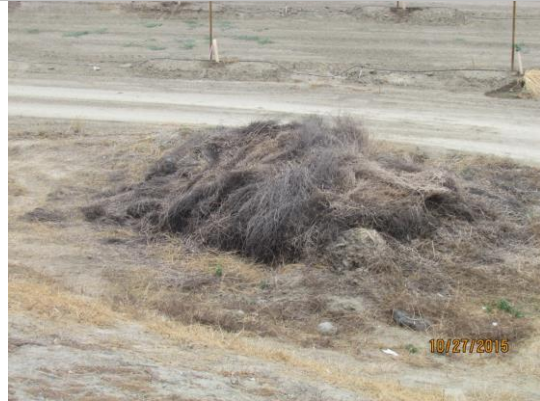
Photo 1 of 1 : FA_2015_RD0537_173_9_20151102_00048.jpg

View of the prunings at the levee toe on the landward side of the levee. Fall 2015.

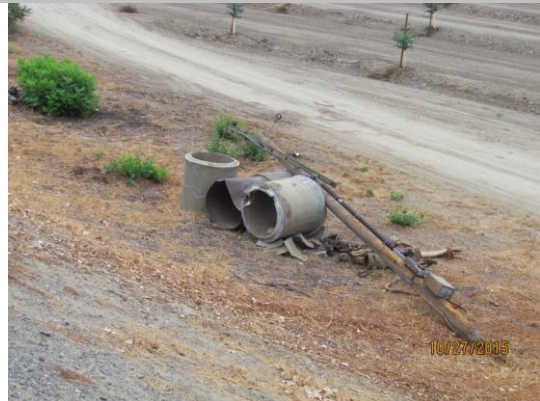
Photo 1 of 1 : FA_2015_RD0537_173_14_20151102_00049.jpg

View of concrete debris and a utility pole on the landward side of the levee. Fall 2015.

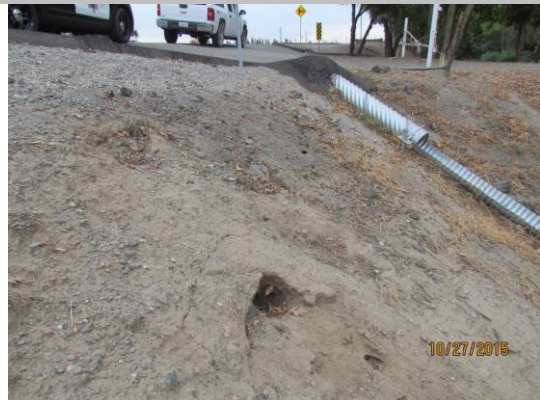
Photo 1 of 3 : FA_2015_RD0537_173_15_20151102_00050.jpg

View of the rodent hole on the landward side of the levee looking downstream. Fall 2015.

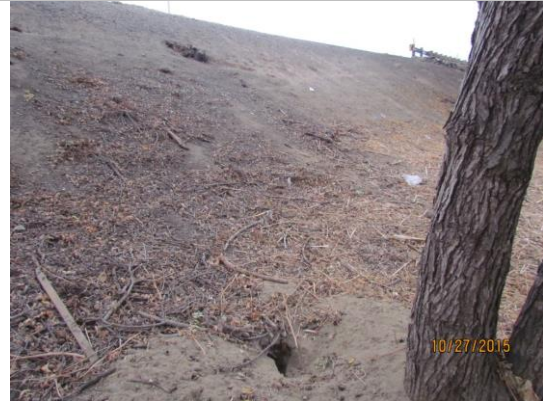
Photo 2 of 3 : FA_2015_RD0537_173_15_20151102_00052.jpg

More rodent holes a little further upstream. Fall 2015.

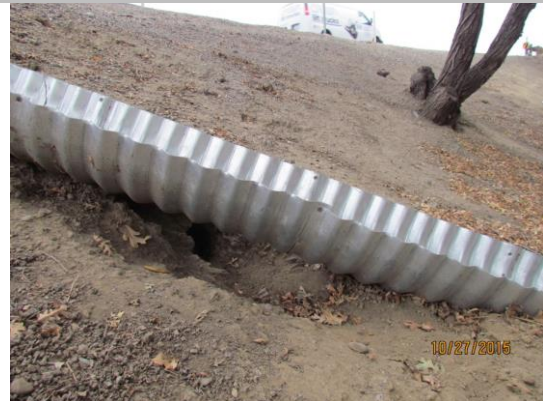
Photo 3 of 3 : FA_2015_RD0537_173_15_20151102_00051.jpg

There is a rodent hole under the pipe spill way. Fall 2015.

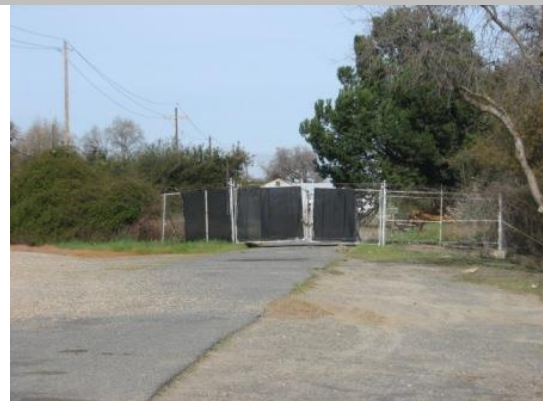
Photo 1 of 2 : FA_2015_RD0537_173_8_20150914_00012.jpg

Abandoned building and fence on the levee crown. Spring 2013

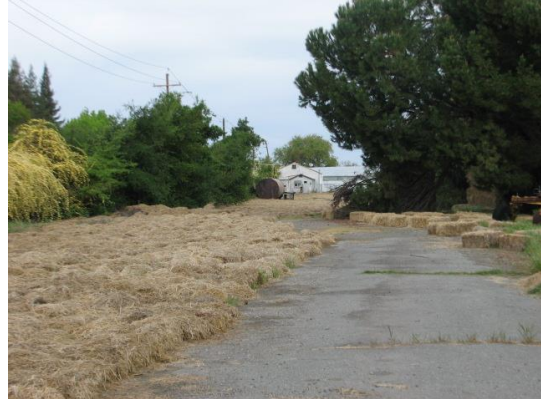
Photo 2 of 2 : FA_2015_RD0537_173_8_20150914_00013.jpg

Building and old equipment within the fenced compound. Spring 2014

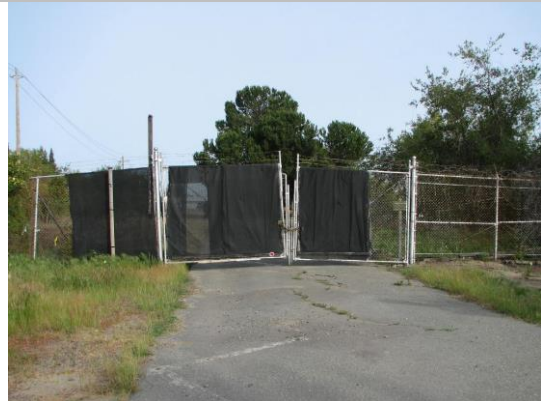
Photo 1 of 3 : UCIP_FA_2015_0267.jpg

No access through gate. Area behind gated area along WS slope accessible.

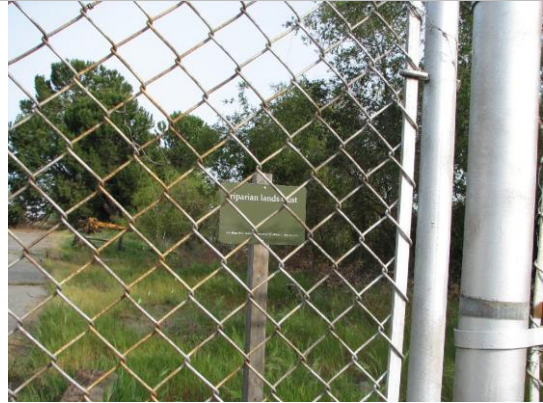
Photo 2 of 3 : UCIP_FA_2015_0268.jpg

Riparian Lands Trust- no access through gate.

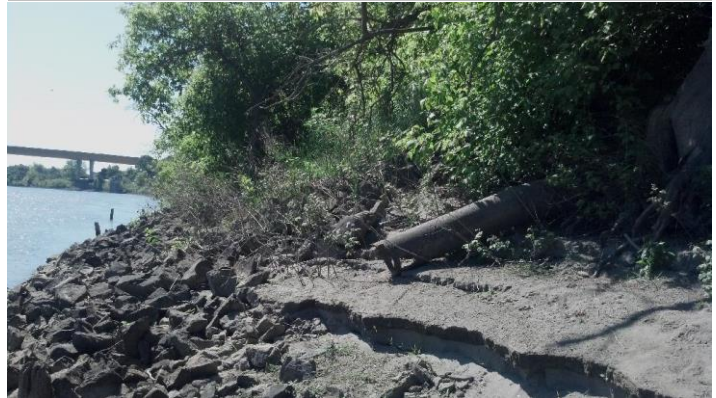
Photo 3 of 3 : UCIP_FA_2015_5790.jpg

12" pipe along WS slope resting on possible remnant of pump house.

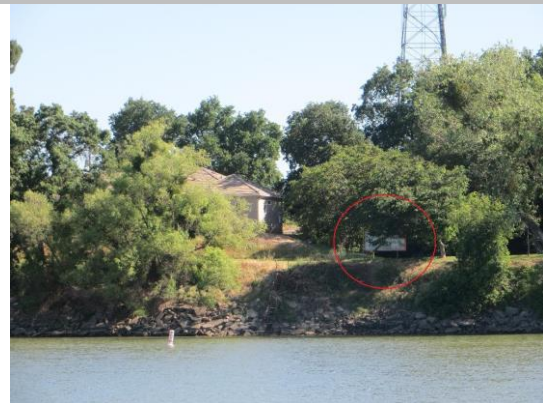
Photo 1 of 3 : UCIP_FA_2015_6263.jpg

Red circle shows location of sign on opposite bank.

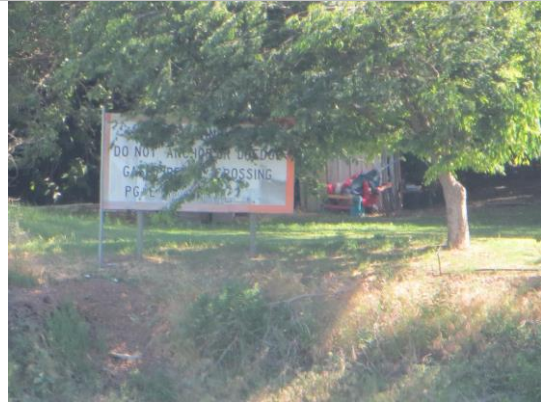
Photo 2 of 3 : UCIP_FA_2015_6264.jpg

Closeup of PGE "Gas Pipeline Crossing" sign on opposite bank.

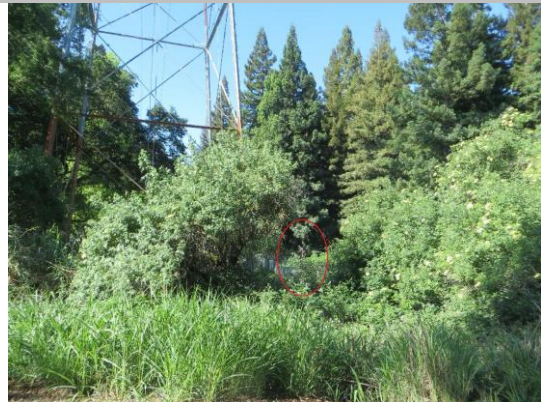
Photo 3 of 3 : UCIP_FA_2015_6265.jpg

Marker off LS toe at base of tower at opposite side of RR tracks.

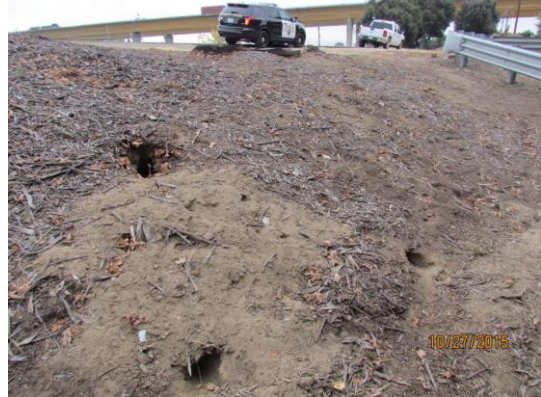
Photo 1 of 1 : FA_2015_RD0537_173_475_20151102_00053.jpg

View of the rodent hole on the landward side of the levee looking downstream. Fall 2015.

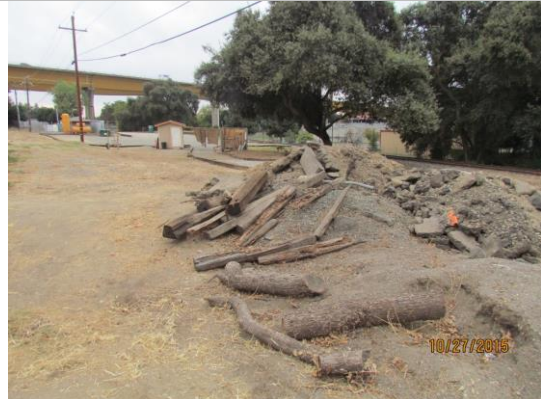
Photo 1 of 1 : FA_2015_RD0537_173_16_20151102_00054.jpg

View of debris and rocks on the landward side of the levee looking downstream. Fall 2015.

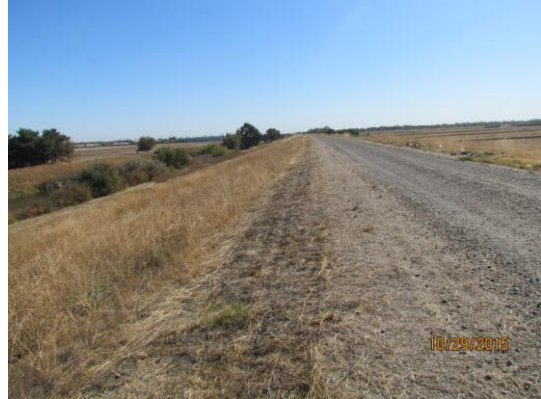
Photo 1 of 1 : FA_2015_RD0537_174_2_20151103_00004.jpg

View of the vegetation on the landward side of the levee looking upstream. Fall 2015.

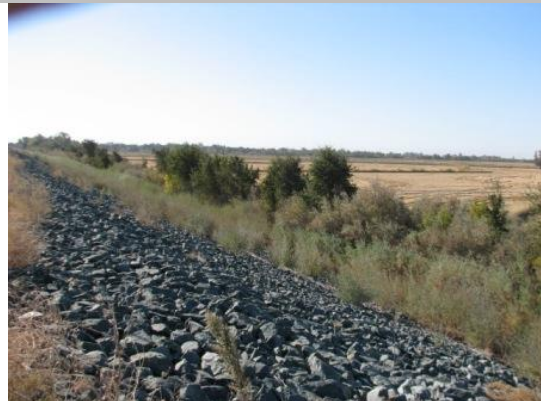
Photo 1 of 4 : FA_2015_RD0537_174_4_20150914_00001.jpg

Trees are at the toe of the waterside levee. Sandbar Willows are creeping up the slope. Fall 2013

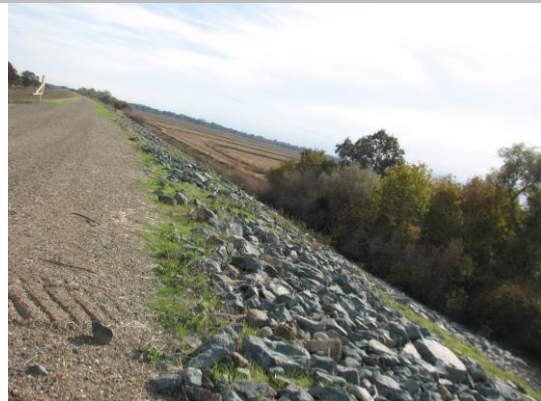
Photo 2 of 4 : FA_2015_RD0537_174_4_20150914_00002.jpg

Levee mile 0.00, vegetation at the toe of the levee. Fall 2014.

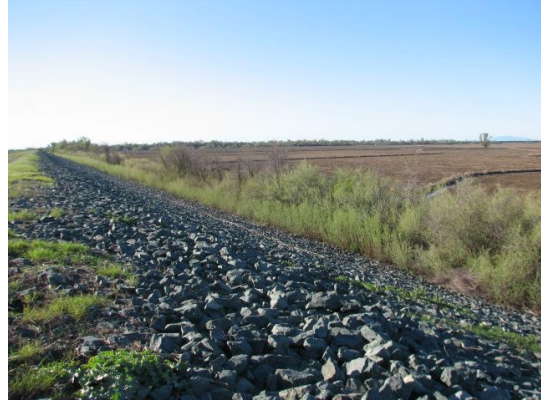
Photo 3 of 4 : FA_2015_RD0537_174_4_20150914_00003.jpg

Photo of the willows at the toe of the rip rap and levee. No other trees in the rip rap. Spring 2014

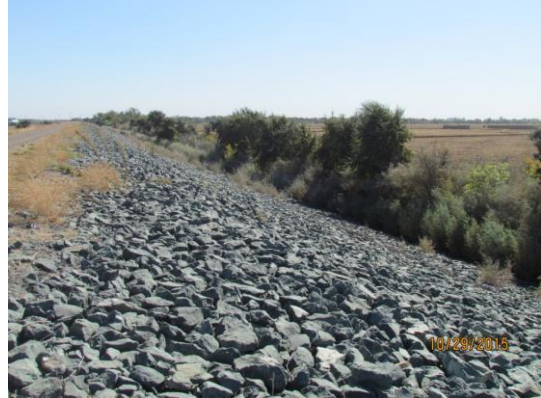
Photo 4 of 4 : FA_2015_RD0537_174_4_20151103_00005.jpg

View of the willows at the toe of the waterward side of the levee looking upstream. Fall 2015.
